Navajo Abandoned Uranium Mine

Site Screen Report

Climax Transfer Station AUM Site

August 2010

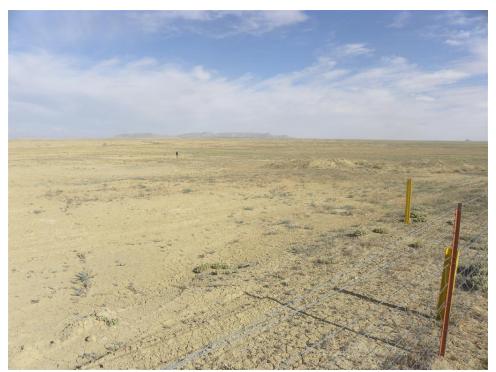
Climax Transfer Station consists of an area of 8,648.54 m². The mine was not identified as ever being operational. No other historical information or any additional ownership / lease information was identified in the EPA/AUM database.

Photo 1. Climax Transfer Station site

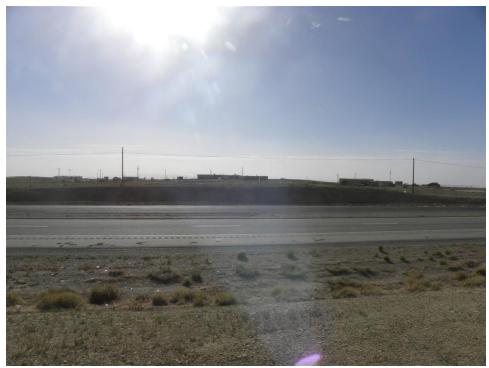
200 feet to 0.25 mile: A housing compound with 6 houses was found across Hwy 491, approximately 0.1 mi W of site

Photo 2. Housing compound across Hwy 491, W of site

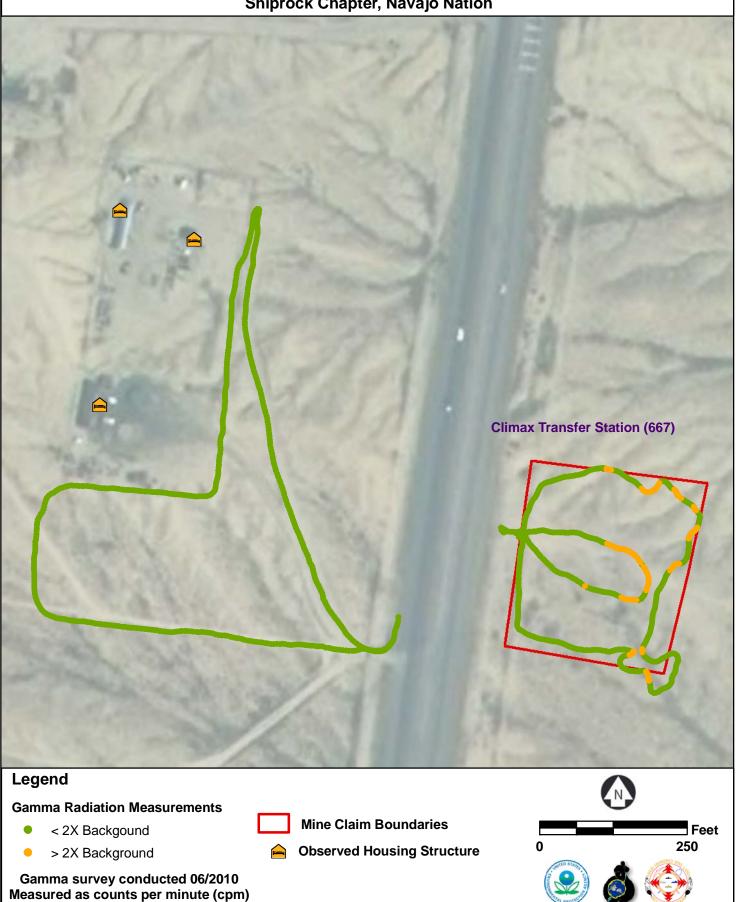
Figure 1 - Gamma Radiation Measurements, Above Two Times Background
Climax Transfer Station (667)
Shiprock Chapter, Navajo Nation

A total of 611 gamma radiation measurements were collected from the mine site, ranging from 10,470 cpm to 29,170 cpm. Measurements collected from some low-lying areas were found at levels up to approximately 30,000 cpm. The measurements are represented in Figures 1 and 2.
